# Property Inspection Report

Apartment - Dubai Marina

FI-SAMPLE-2418

Handover Inspection

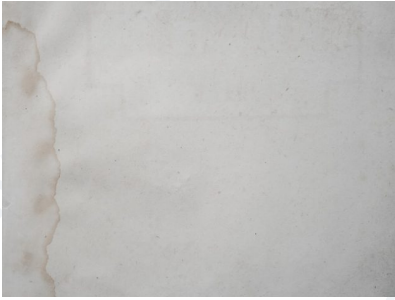
### L-01 Water staining to ceiling

**CRITICAL**

**Observation:** Brown moisture staining observed to ceiling and wall near the bathroom, consistent with a possible water ingress path.

**Recommended action:** Investigate the source above the ceiling void and rectify; re-inspect after drying.

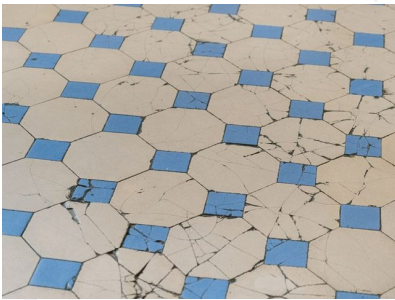
### L-02 Cracked / drummy floor tiles

**MAJOR**

**Observation:** Multiple cracked and hollow-sounding tiles across the floor finish.

**Recommended action:** Replace affected tiles and re-grout to match.

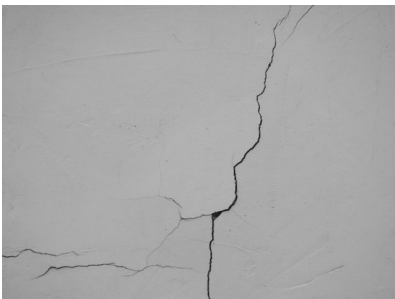
### L-03 Crack to wall finish

**MINOR**

**Observation:** Visible crack tracking across the plastered wall surface.

**Recommended action:** Rake out, fill and redecorate; monitor for recurrence.

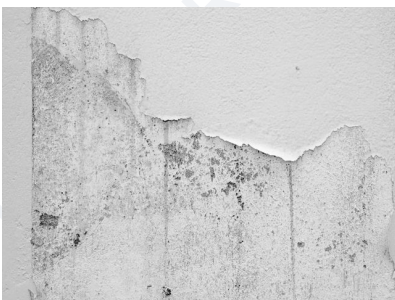
### L-04 Paint & finishing defect

**MINOR**

**Observation:** Patchy, peeling paint and incomplete finishing to the wall.

**Recommended action:** Rub down, make good and re-coat to an even finish.
